CORROSION OF ALUMINUM ALLOYS IN EXFOLI-  
ATION-RESISTANT TEMPER EXPOSED TO MARINE  
ENVIRONMENTS FOR 2 YEARS

Ernest J. Czyryca, et al

Naval Ship Research and Development Center  
Annapolis, Maryland

November 1974

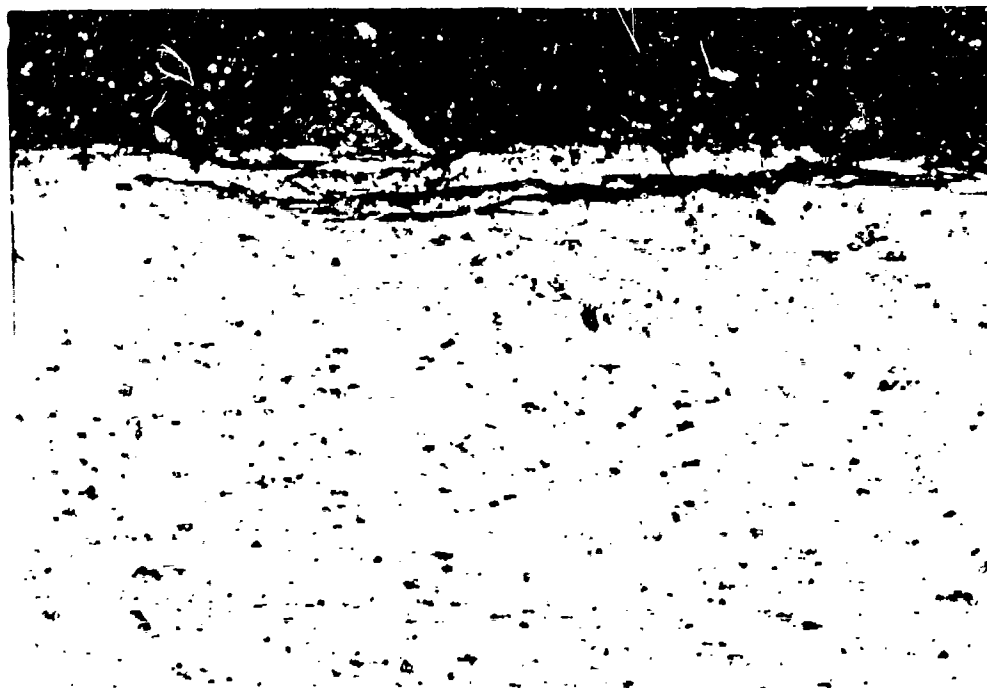
The panels exposed to marine atmosphere and to splash and spray showed a scattered light pitting on surfaces, with a slightly greater intensity in the latter exposure. The pitting can best be described as "pinpoint" and of insignificant depth. The one exception to this general behavior was that of the sensitized, 1/4-inch-thick 5456-H117 panels. In both environments, the attack on these panels appeared as a minor scattered surface blistering. The attack was first noted after 1 year of exposure, being the only instance of increased corrosion rate at that time; however, the rates after 2 years of exposure show the attack to have virtually ceased.

Figure 12  
Delamination Under Blistering on  
Sensitized 5456-H117 1/4-Inch Plate  
After Splash and Spray Exposure  
(250X)
